A Survey of the Hydrogeologic Integrity of Earthen Hog Manure Storage Ponds in Alberta

William R. MacMillan

A thesis submitted to the Faculty of Graduate Studies and Research in partial fulfillment of the requirements for the degree of *Master of Science*

Fall 2000

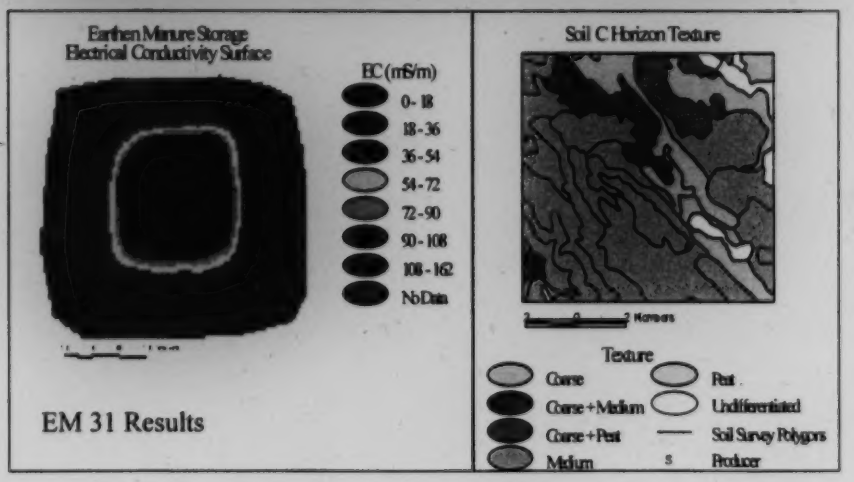
- A thorough site-specific investigation by a qualified professional would have resulted in a recommendation for a pond liner at this site or perhaps even a steel or concrete tank.

Figure 4.1. Site 1 layout and location diagram showing the location of the soil sample and piezometers, the EM 31 electrical conductivity surface and the C-horizon soil parent material map for the area from the AGRASID database (Nikiforuk et al. 1998)

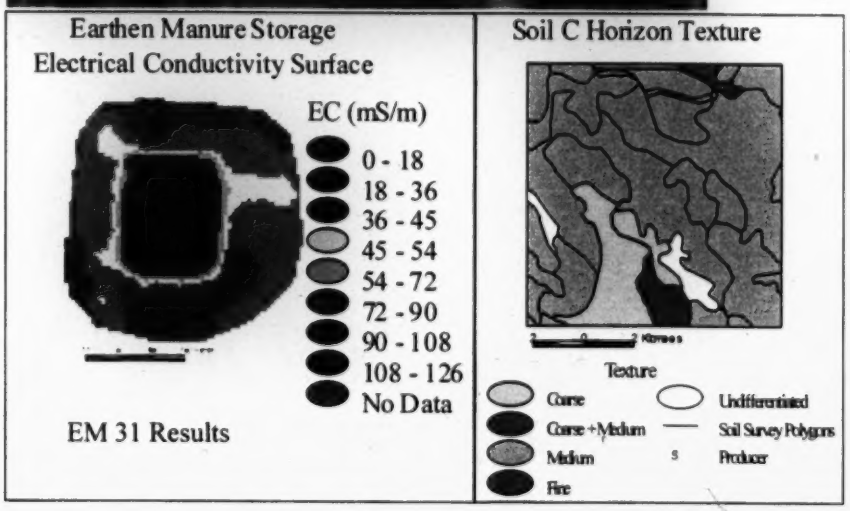
The remote resource data for this site provided a good overall picture of the nature and characteristics of the soil and geologic materials found at this site during the site-specific investigation. Soil survey and quaternary geology data predicted the presence of a relatively shallow glacial till soil with a clay content of about 30%, confirmed by the site-specific investigation. A review of these data prior to construction of the EMS pond would likely have prompted a preliminary site investigation and perhaps better EMS pond design and construction. However, the improved quality control during construction this would have resulted in only a marginal decrease in seepage and contaminant movement into the downslope berm of this EMS pond.

Figure 5.1 Site 2 Layout and location diagram showing the location of the soil sample and piezometers, the EM 31 electrical conductivity surface and the C-horizon soil parent material map for the area from the AGRASID database (Nikiforuk et al. 1998)

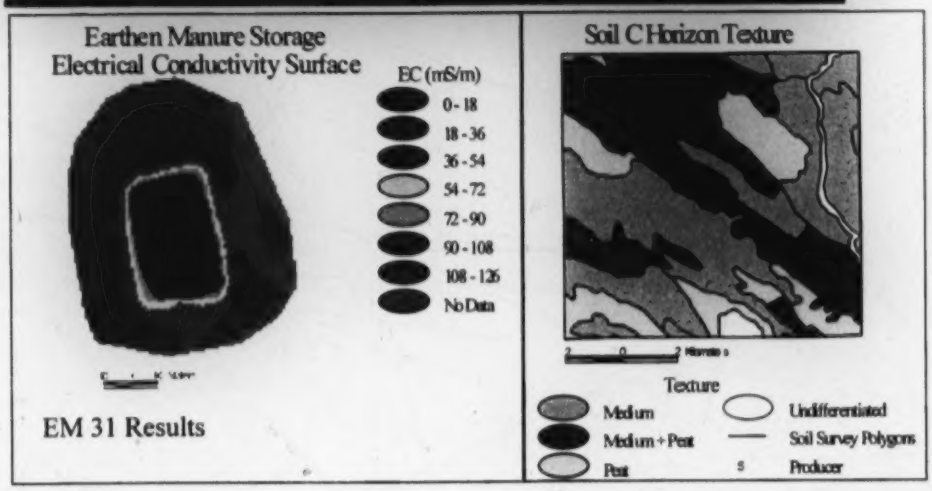
Seepage into the topsoil layer under the berm is elevating NO_3, Cl and salt concentrations within that soil zone. Elevated levels of these chemicals in the soils immediately below the seepage zone indicate downward movement of the seepage waters. Elevated chloride levels to the depth of 2.4 – 3.1 m indicate that the downward movement of the seepage front extends to this depth. The lack of a major increase in either moisture content or NH_4 concentration within the seepage zone suggests that seepage into the berm is periodic. This may imply that manure sealing is preventing seepage from occurring continuously into the topsoil seepage zone from the EMS pond. Seepage likely occurs for an indefinite period after the EMS pond is filled to the level where the topsoil layer exists until the manure can clog the soil and prevent further seepage from occurring. This likely occurs intermittently as the EMS pond is emptied and filled, resulting in a pulse flow into the topsoil layer. This would also result in periodic oxidation of the NH_4 as the soil would dry during periods of no seepage, thus accounting for the zone of high nitrate surrounding the topsoil seepage zone.

Figure 6.1 Site 3 layout and location diagram showing the location of the soil sample and piezometers, the EM 31 electrical conductivity surface and the C-horizon soil parent material map for the area from the AGRASID database (Nikiforuk et al. 1998)

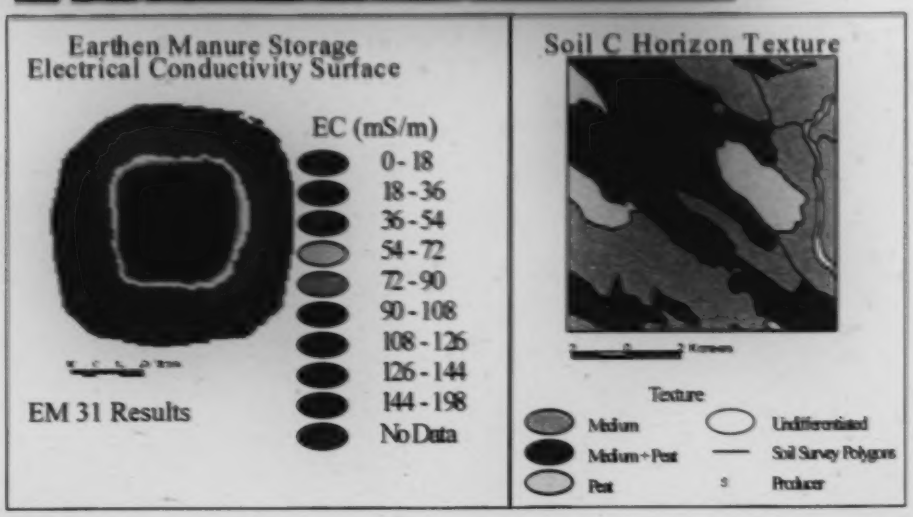
- Seepage into the sand lenses, the bedrock interface and tree root pathways from this EMS pond is likely being limited by a periodic development and breakdown of a manure seal in this EMS.
- Evidence that seepage is occurring through sand streaks and along the bedrock interface supports the idea that a soil buffer should be present between the bottom of the EMS ponds and the bedrock layer.
- The seepage mechanisms here show the importance of proper siting and engineering design of EMS ponds located in variable soil conditions.

Figure 7.1 Site 5 Layout and location diagram showing the location of the soil sample and piezometers, the EM 31 electrical conductivity surface and the C-horizon soil parent material map for the area from the AGRASID database (Nikiforuk et al. 1998)

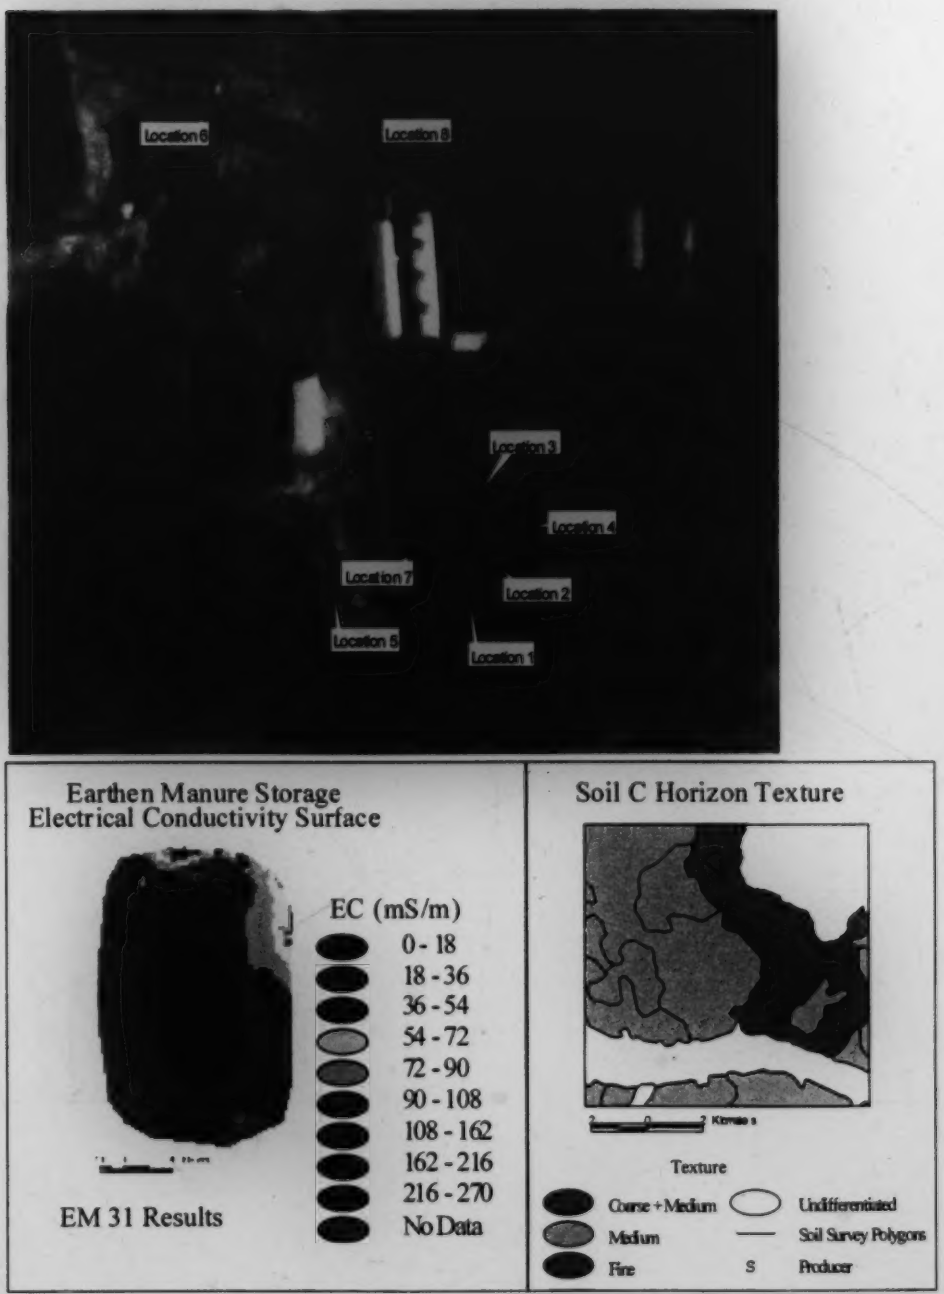
- Soil and water chemistry anomalies initially attributed to EMS seepage appear to be better explained by a major manure spill that occurred in July 1999.
- Contamination of the soil and water at this site due to the spill event confounded the interpretation of study results at this site.
- A Phase I site assessment with remote resource data would have identified the need for a site-specific investigation to assess the environmental security of this site.
- A proper site investigation prior to construction of this EMS would have identified the inherent problems with this site that are the cause of the minor seepage found here.
- A properly constructed liner and berm would have prevented the seepage shown to occur from the EMS pond at this site.

Figure 8.1 Site 8 Layout and location diagram showing the location of the soil sample and piezometers, the EM 31 electrical conductivity surface and the C-horizon soil parent material map for the area from the AGRASID database (Nikiforuk et al. 1998)
